Manhole Inspection Summary

Manhole # S53K__064MH

Insp Date: **7/29/08 11:34 AM**

Location Address: **800 fait Av**

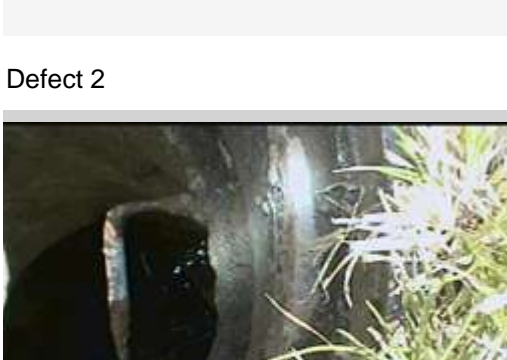
bench debris

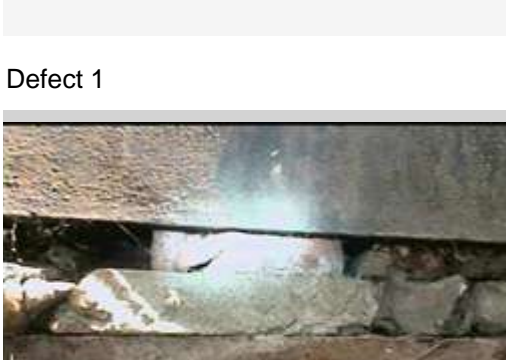
Steps Count: **6** Missing: **3** ☒ **Corroded**

steps

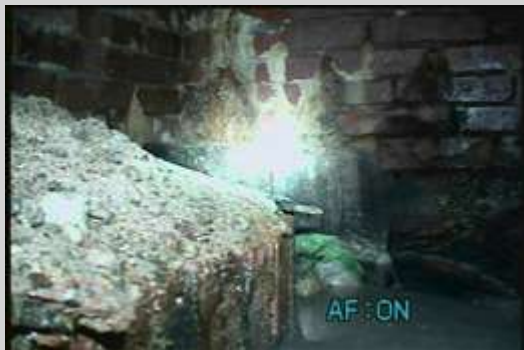
12 O'Clock Outflow

Comments **direction of 12 is different than on map**

very strangely angled pipe
